## SERVICE BULLETIN

**TITLE: WINGS - WING ATTACH BOLT INSPECTION/REPLACEMENT**

This Service Bulletin is being issued to define an inspection procedure for the wing attach bolts and attach fittings, and to establish a recurring Time In Service (TIS) inspection/replacement schedule for the wing attach bolts.

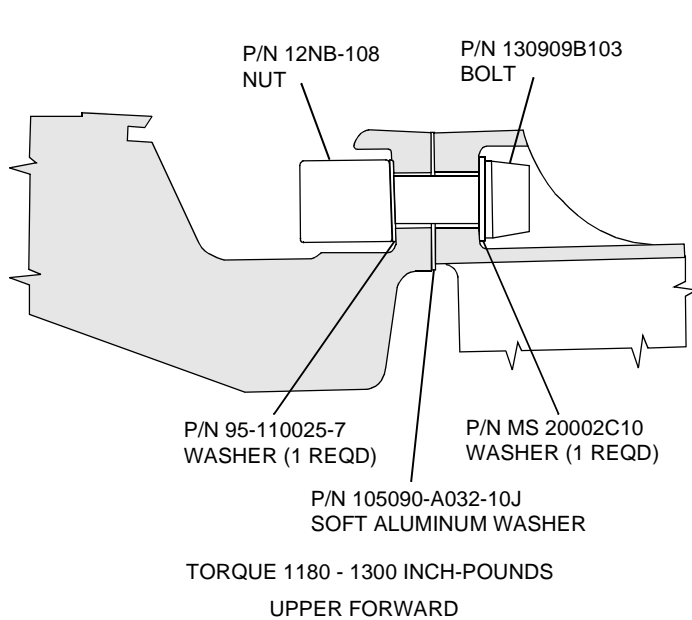
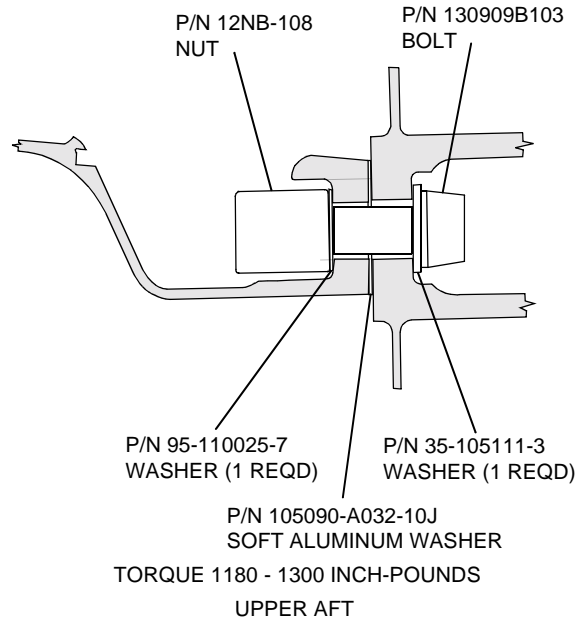
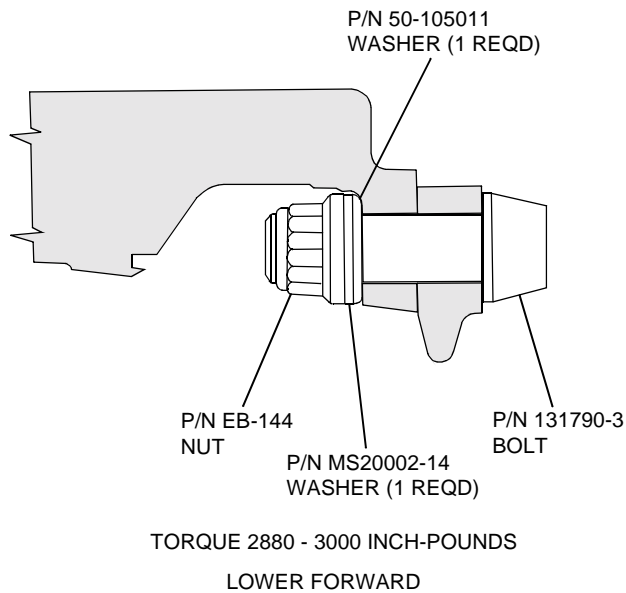
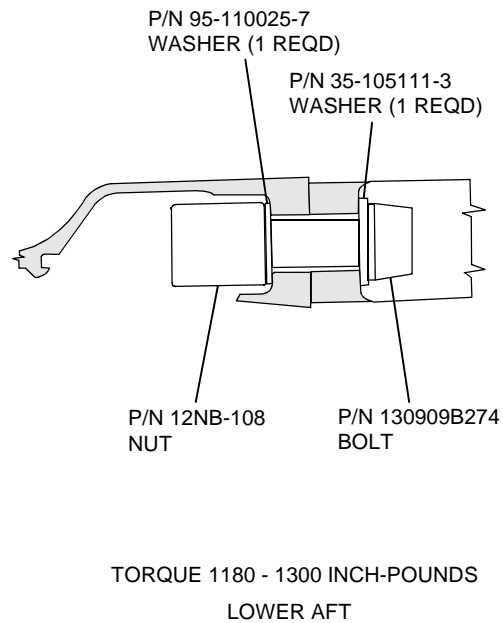
**Figure 1**

**T-34A Wing Attach Bolt Installation**

- (12) Install the bolt, washer or washers and nuts in their respective hole (See Figure 1 or Figure 2 to determine the correct hardware for different models) and torque to:
  - (a) Install soft aluminum washers between the upper wing fittings, if the wings were shifted during bolt removal.
  - (b) Torque the lower front spar attach bolts to 2880-3000 inch-pounds.
  - (c) Torque the remaining attach bolts to 1180-1300 inch-pounds.

- (14) At the next 100 hour inspection after the wing bolts have been loosened and torqued, check each bolt for proper torque. See Figure 1.
- (15) Affix the decals to the airplane as shown in Figure 4.

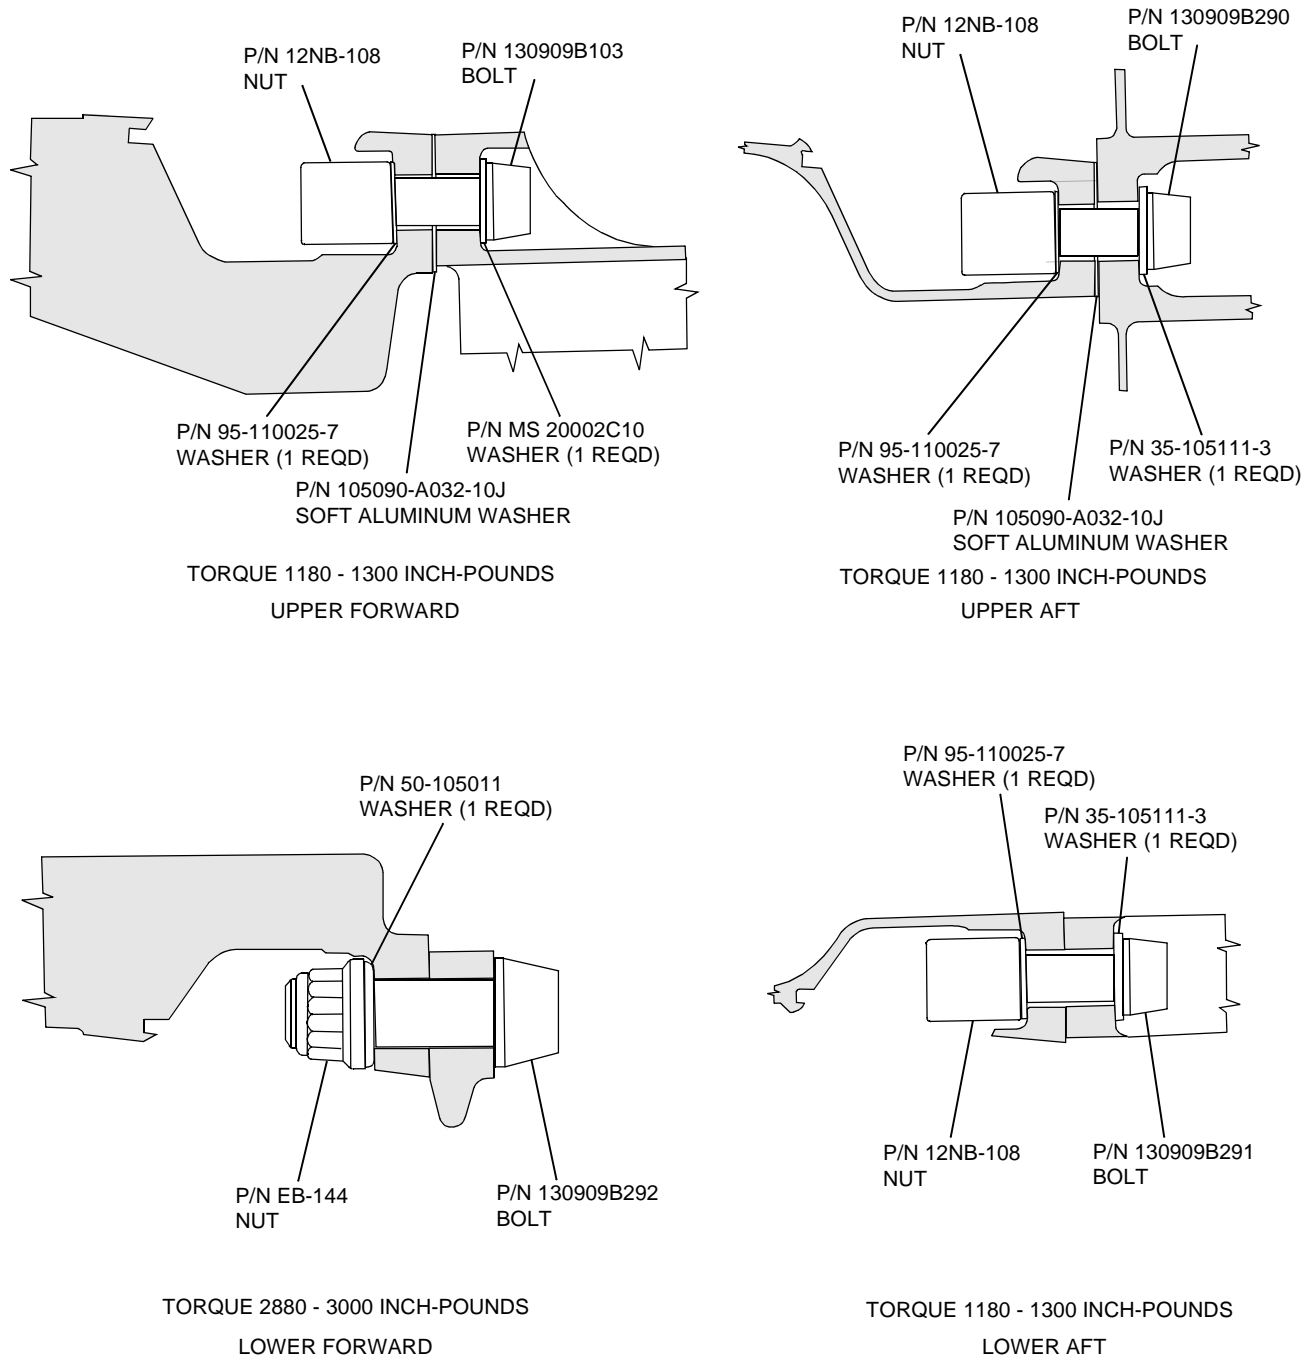
**Figure 2**

**T-34B/D45 Wing Attach Bolt Installation**

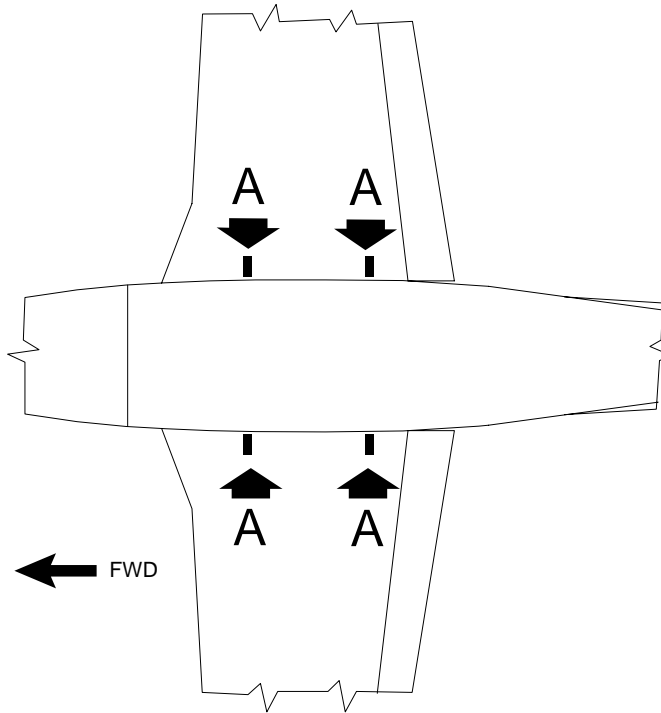
Location for Decal Installation  
Figure 4

WING BOLTS ARE LUBRICATED  
SEE SERVICE BULLETIN 57-3458  
FOR CORRECT TORQUE VALUES

- (d) Position the selected decal(s) on the side of the fuselage (above the wing) and adjacent to the access panels on the lower side of the wing as shown in Figure 2.
- (e) Trim excess background from decal(s) as needed.
- (f) Peel the backing from the decal(s) and apply it to the airplane surface. Verify that the decal is affixed firmly and that all bubbles are removed.
- (g) Apply EC-3960 edge sealer around the perimeter of the decal with a minimum of 1/8th inch sealer overlap.
- (16) Remove the support cradles and remove the airplane from jacks.
- (17) Reconnect the airplane battery, remove warning notices and restore power.
- (18) Ensure all work areas are clean and clear of tools and miscellaneous items of equipment.
- (19) Return airplane to service.
