[Docket No. FAA-2006-25105; Directorate Identifier 2006-CE-33-AD; Amendment 39-14982; AD 2007-06-01]

Airworthiness Directives; Raytheon Aircraft Company Beech Models 45 (YT-34), A45 (T-34A, B-45), and D45 (T-34B) Airplanes

2007-06-01 Raytheon Aircraft Company: Amendment 39-14982; Docket No. FAA-

Surface Eddy Current Inspection Procedure

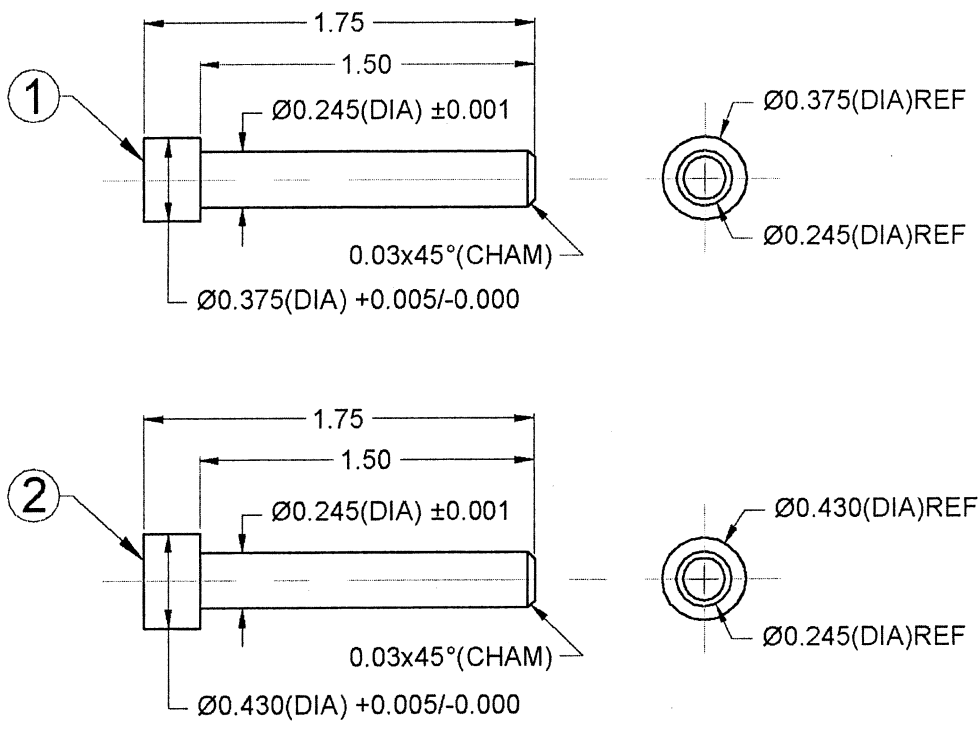
KEY	PART NO.	DESCRIPTION	SIZE	MATERIAL SPEC.	HEAT TREAT	NOTES
2	45-127-2	BUSHING TOOL	Ø0.44(DIA) x1.75	ALUMINUM		BREAK ALL SHARP EDGES
1	45-127-1	BUSHING TOOL	Ø0.38(DIA) x1.75	ALUMINUM		BREAK ALL SHARP EDGES
