**PRODUCT IMPROVEMENT
DIGEST**

T-34A

AFPS-SAAMA-7-58-3020

30 MAY 1958

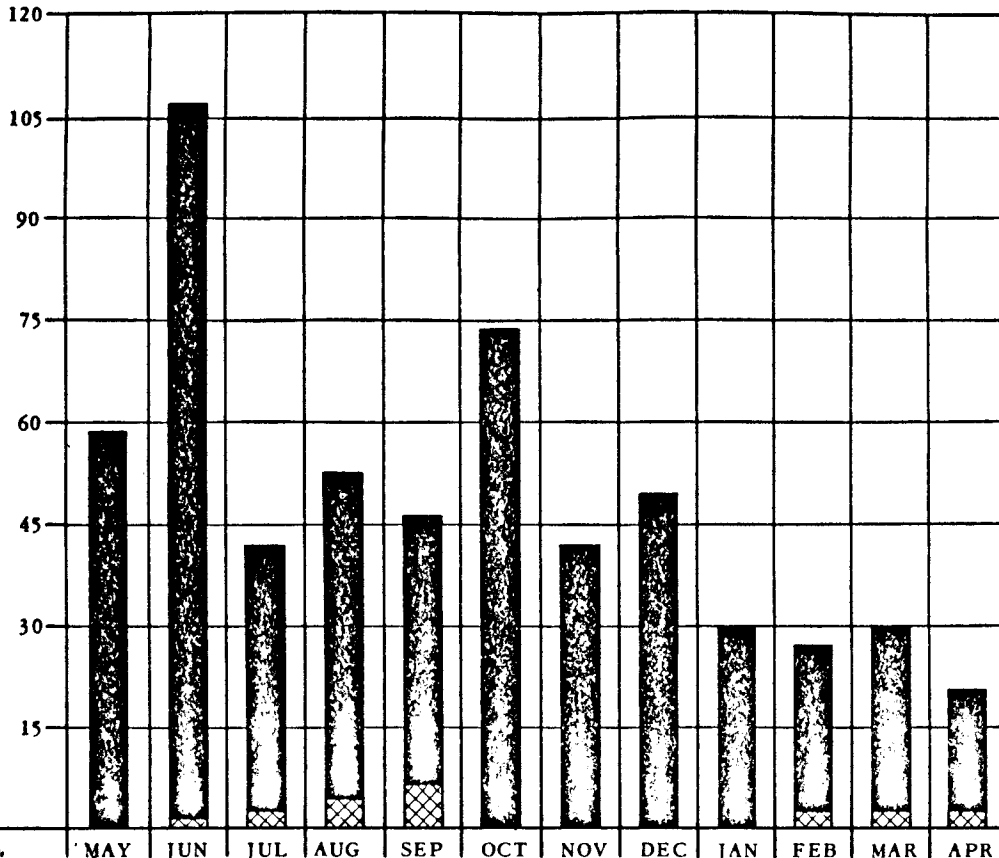
UNSATISFACTORY REPORTS

PERIOD (MONTHS, YRS, QTRS, ETC)	MAY	JUN	JUL	AUG	SEP	OCT	NOV	DEC	JAN	FEB	MAR	APR	TOTAL
	1957						1958						
TOTAL	59	107	42	52	46	74	42	49	30	27	30	20	578
AIRFRAME	3	9	4	3	2	10	7	2	1	3	4	2	50
LANDING GEAR	11	16	4	10	5	12	1	8	6	5	5		83
HYDRAULIC													
UTILITY	1				1			7					9
POWER PLANT	8	28	15	12	14	23	16	14	6	8	7	10	161
FUEL	3	2	6	5	6	6	2		5	1		2	38
OIL	1	1											2
IGNITION	10	13	5	2	3		5	11	2	4			55
EXHAUST		1							1				2
PROPELLER	7	15	3	12	5	14	5	4	7	2	10	4	88
COOLING													
ELECTRICAL	12	17	3	8	9	8	5	2	2			2	68
INSTRUMENTS	3	4	2		1	1	1	1		1	1		15
RADIO & RADAR		1								3	3		7
ARMAMENT													
PHOTOGRAPHIC
